McNab Creek Project:
Blocks G063C3UW, G053C39P–A, B, C
and Associated Access Roads
Terrain Stability Assessment Report

McNab Creek Area
(Sunshine Coast Forest District)

January 15th, 2013

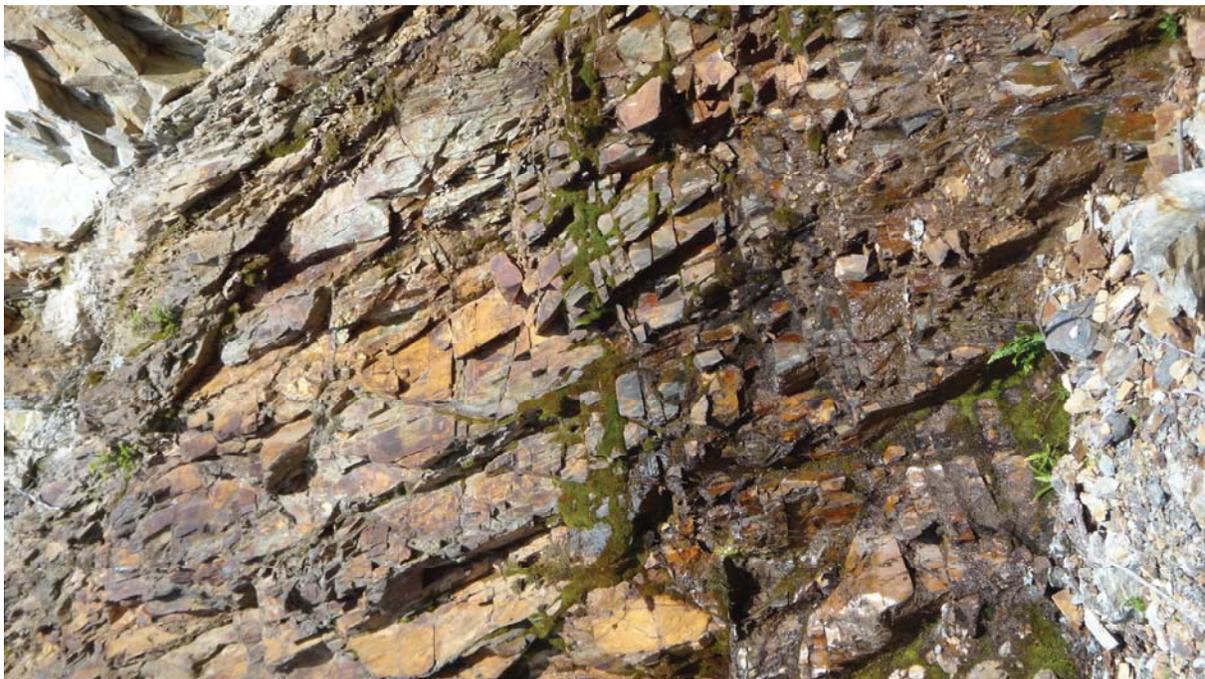
Photo 1: Rock below Block G053C39P-B in the FC B9 vicinity along existing road 2311-047.

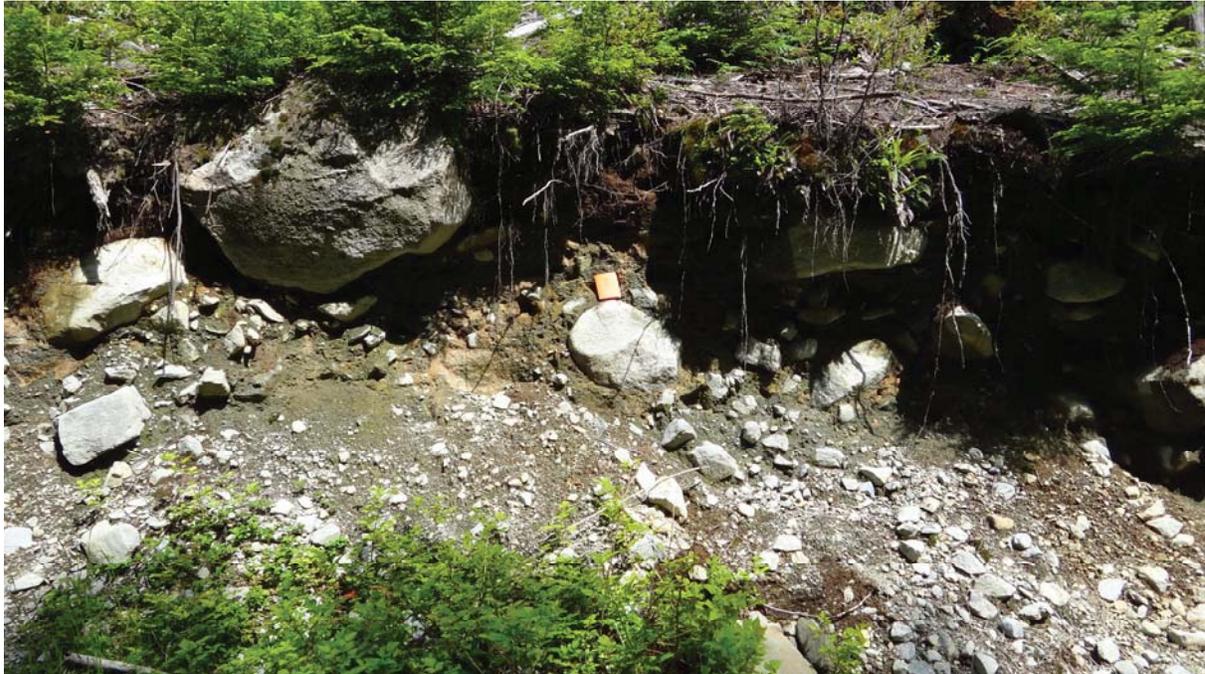
Photo 2: G063C3UW area, 2620 cutbank soils: variable thick till and colluvium.

The till is exposed intermittently in the local road cuts. The till tends to be of blanket thickness of up to 3m in the lowermost study area elevations. This unit thins upslope to veneer thickness and at the uppermost elevations, is absent. The till is composed of approximately 5% to 10% cobble to rubble material, 10% gravel, 25% to 30% sand, 30% to 45% silt and 10% clay (visually estimated). This unit is moderately dense (semi-compact, basal till) and was observed to hold up moderately well in existing cutbanks.

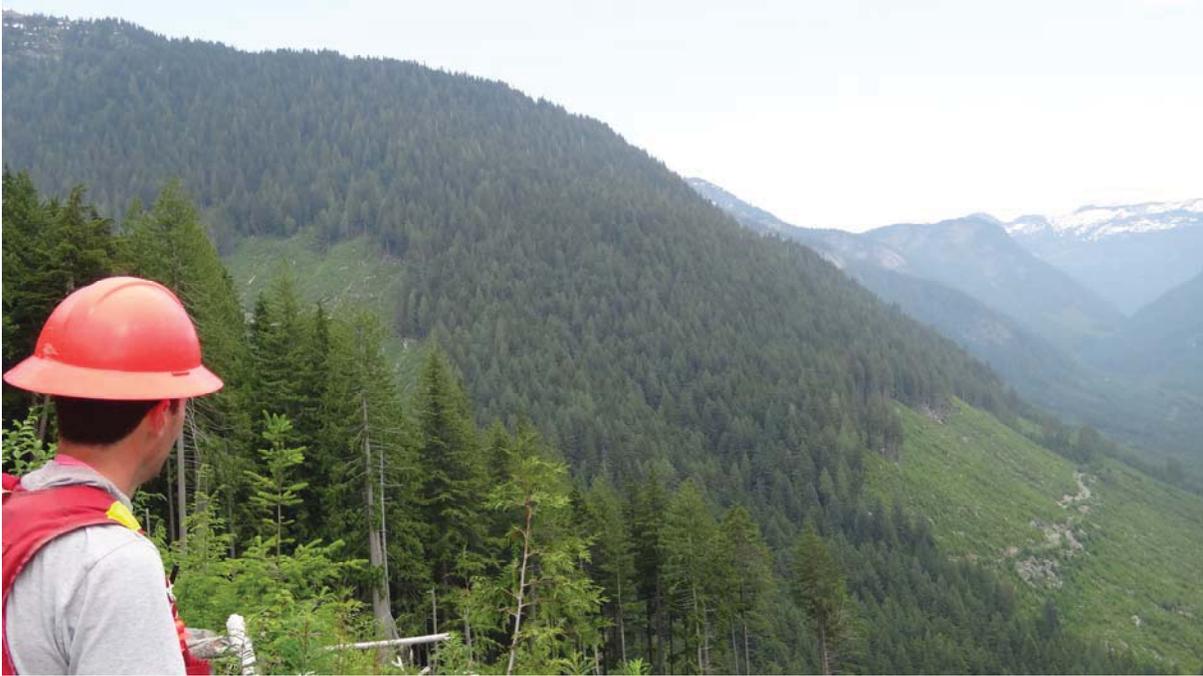
Photo 3: View from 2311-047 looking at slopes within proposed block G063C3UW.
